HP-14 Accident That Almost Happened

by
Wayne Paul

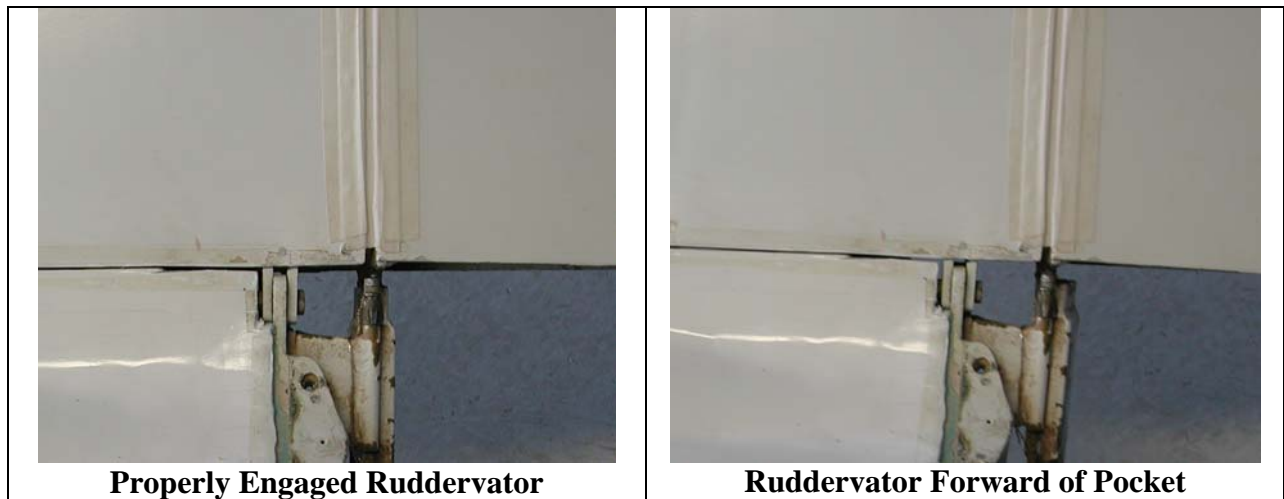
My post flight inspection revealed the right ruddervator was not engaged in the actuator pocket. It was sitting in front of the pocket. This prevented ruddervator actuation when the stick was pulled back although it provided ruddervator movement when the stick was pushed forward.

I believe the mental distraction associated with my frustration with Norco not having filled the O2 bottle was a factor in my overlooking the ruddervator/actuator disengagement. In addition, the rush to launch caused me to skip the “positive control check.”

My HP-14’s ruddervators are 12 inches longer than the standard HP-14. It is likely the additional area provided more control authority. As stated earlier, the disconnected ruddervator rests in front of the actuator pocket. Nothing happens when the stick was pulled back; however, the actuator pocket pushes against the ruddervator when the stick was pushed forward. Taking off with 10 degrees of flap requires forward stick pressure allowing a bit more control.

I removed the tail cone; folded the ruddervator, then spread and properly engaged; and, then the tail cone was reattached and taped. After a positive control check, I launched, released at 2000 feet AGL and had a great flight on the Logan ridge.

1. A homebuilt sailplane does not have an owner’s manual with an assembly check list, so create one, *AND USE IT!*
2. Check and re-check ruddervator engagement prior to attaching the tail cone.
3. Always perform a positive control check after assembly.
4. Finally, if you ever should find yourself flying a Schreder sailplane with a ruddervator disengaged, lower the flaps.

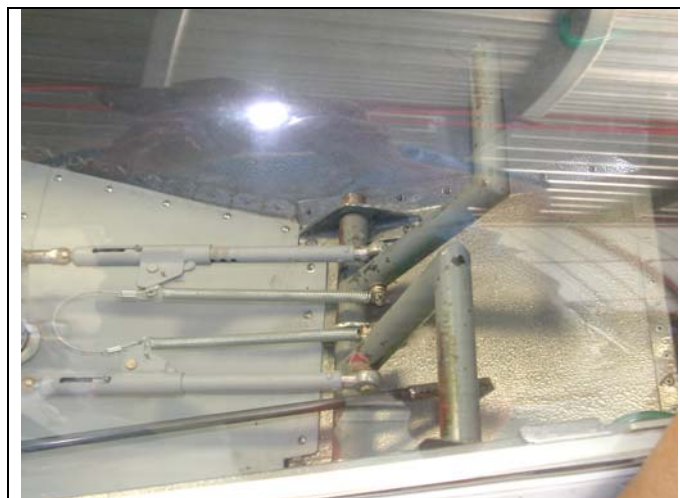
With the gust locks installed a disengaged ruddervator caused pedals to be offset.
